# Evidence of Performance

Testing the joint characteristics of a sealing between window and building structure in new condition and after a series of simulated time-lapse short-term loads

N° 18-002553-PR02

<b>Client</b>	Hermann Otto GmbH Otto Chemie Krankenhausstr. 14 83413 Fridolfing Germany
<b>Product</b>	Sealing system between window and building structure
<b>Designation</b>	Sealing internal / external: OTTOSEAL® M 360 with backfill twine OTTOCORD PE-B2
<b>Installation situation / Boundary conditions</b>	Hollow block wall with blunt reveal Wall including reveal areas plastered with lime cement plaster Single leaf PVC window 1,230 mm x 1,480 mm, centred in the reveal Fastening and load transfer to the supporting structure on sides and at top via frame screws and bearing pads. Fixing distances on sides and at top $\leq 700$ mm. Adhesive surfaces on masonry pre-treated with OTTO Primer 1225. Test without joint filling Processing according to the specifications of the client
<b>Scope</b>	Internal airtight and external watertight joint between external wall and window / casement doors in PVC with equivalent details, as described above.

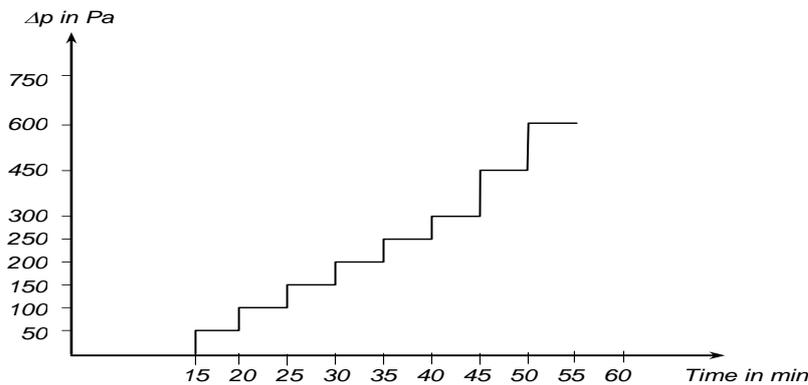
**Illustration 1** Test sequence of watertightness test

Watertightness is tested in accordance with EN 1027 up to the maximum test pressure difference. Using a row of nozzles located at the top, the external face of the test specimen is subjected to constant spraying of water at a flow rate of approx. 2 l/min per nozzle while increments of positive test pressure are applied at regular intervals. (Illustration 1)

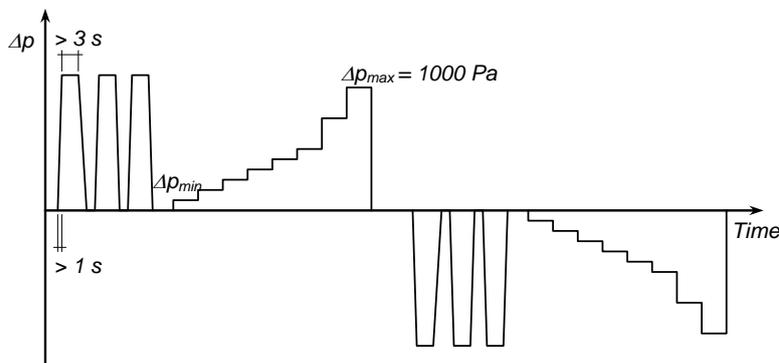
**Illustration 2** Air permeability test - exposure at positive and negative pressures

The air permeability of the sealing system is tested as per DIN EN 12114 at positive and negative pressures, in steps up to a maximum test pressure difference of 1,000 Pa (Illustration 2).

The joints between casement and frame members and the joints along the glazing beads were sealed. Any air leakages in the wall system were taken into account by comparative measurements. It follows that only the air flow through the connecting joint was measured, regardless of any air leakages of the window and the external wall system.

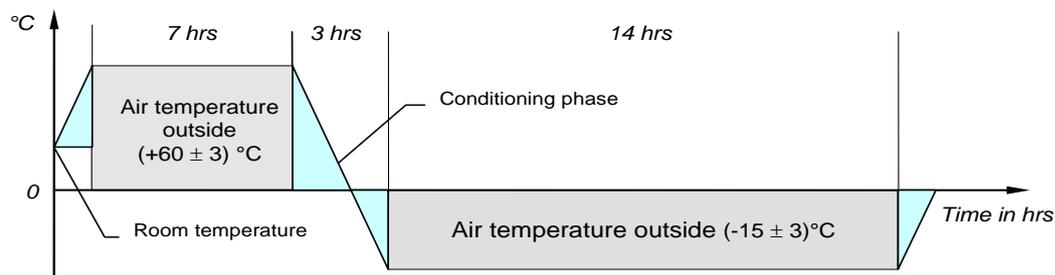
**Illustration 3** Representation of one thermal cycle of exposure to alternating temperatures

The test specimen is pressurized on the outside with the loading by changing temperatures for 10 cycles, as displayed schematically in Illustration 3. During this exposure, the internal face of the test specimen is exposed to room climate.

During and after the exposures, the joining system was checked by visual inspection for any changes. The displacements of the frame member relative to the building fabric perpendicular to the window plane were recorded continually by the linear potentiometers.

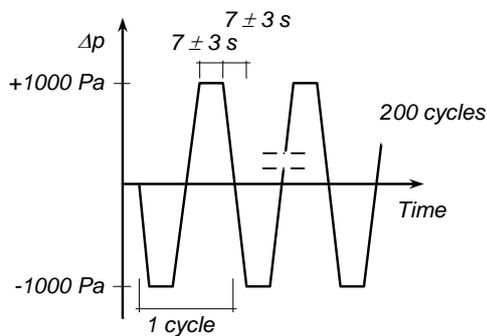
**Illustration 4** Representation of alternating positive/negative pressure pulses

The wind load is applied to the test specimen as pressure-suction-load following DIN EN 12211 with 200 cycles of  $\pm 1,000$  Pa, as displayed schematically in Illustration 4.

During and after the exposures, the joining system was checked by visual inspection for any changes. The displacements of the frame member relative to the building fabric perpendicular to the window plane were recorded continually by the linear potentiometers by comparing the 1<sup>st</sup> cycle to the 200<sup>th</sup> cycle.

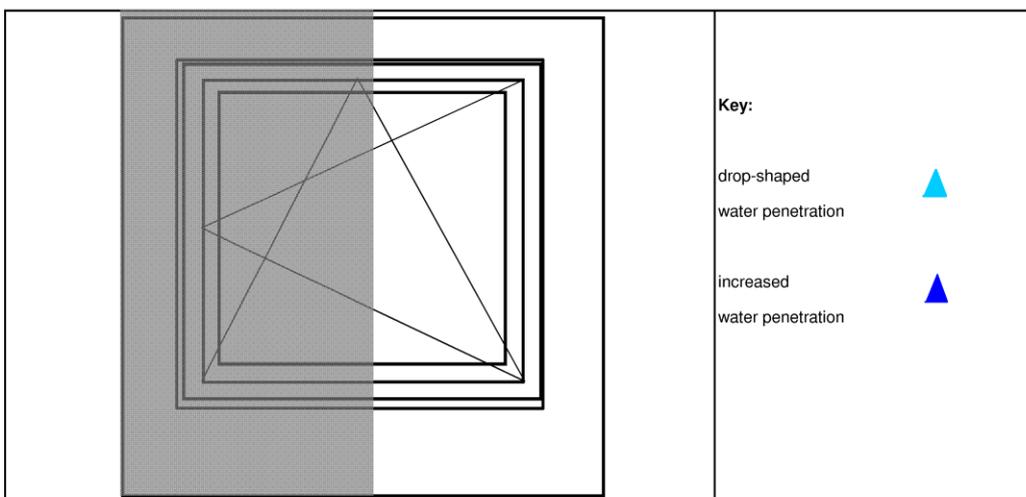
Test state: The test was made without internal connection and joint filling.  
 Number of spray nozzles: 4  
 Amount of water: 480 l/h  
 0.48 m³/h

Three pressure pulses with 660 Pa were applied.

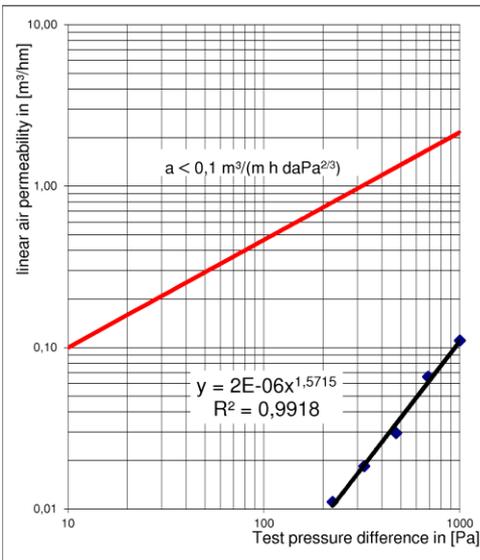
Graphics at positive wind pressure

Pressure difference in Pa	50	73	106	154	224	325	473	688	1000
Flow rate in m <sup>3</sup> /h	*)	*)	*)	*)	*)	*)	*)	*)	*)
Flow rate, in m <sup>3</sup> /hm	*)	*)	*)	*)	*)	*)	*)	*)	*)

\*) no measurable airflow

**Result:** Q10= 0,00 m<sup>3</sup>/hm  
 Q100= 0,00 m<sup>3</sup>/hm

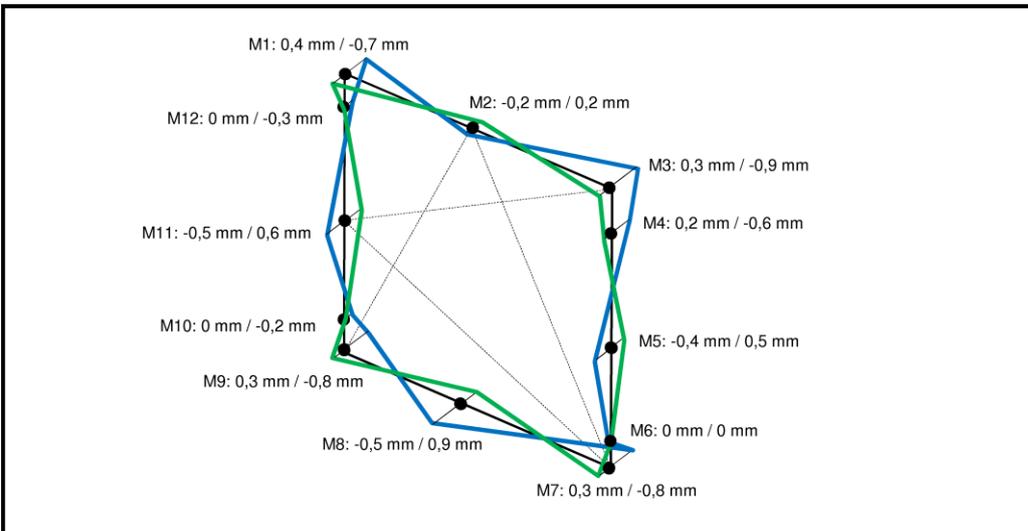
**Measurement data/Results**

Temperature	M1	M2	M3	M4	M5	M6	M7	M8	M9	M10	M11	M12	M13	M14	M15	M16
+60°C	0,4	-0,2	0,3	0,2	-0,4	0	0,3	-0,5	0,3	0	-0,5	0				
-15°C	-0,7	0,2	-0,9	-0,6	0,5	0	-0,8	0,9	-0,8	-0,2	0,6	-0,3

Residual deformation	M1	M2	M3	M4	M5	M6	M7	M8	M9	M10	M11	M12	M13	M14	M15	M16
	-0,3	0	-0,7	-0,3	0,6	0,2	-0,4	0,5	-0,4	0,1	0,5	-0,1

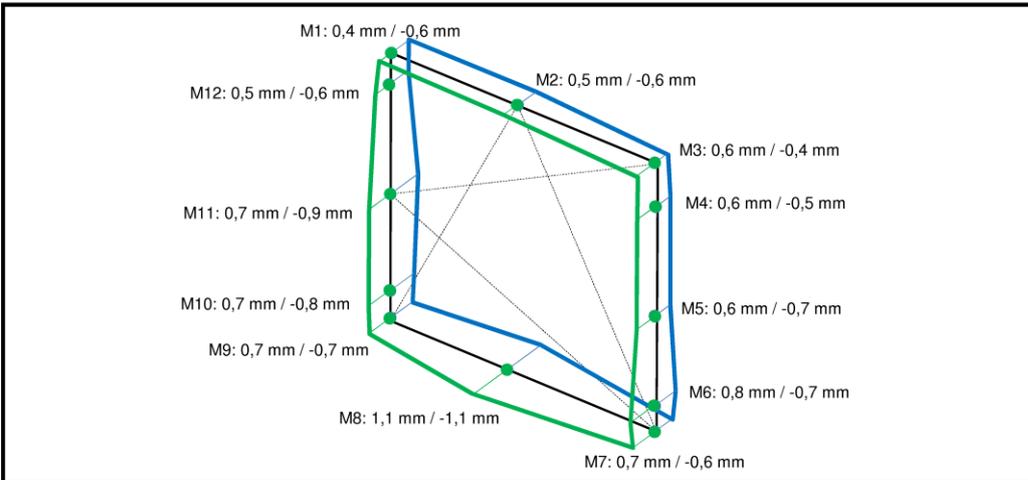
**Measurement data/Results**

First cycle	M1	M2	M3	M4	M5	M6	M7	M8	M9	M10	M11	M12	M13	M14	M15	M16
	0,4	0,4	0,4	0,5	0,5	0,7	0,7	1,0	0,6	0,5	0,5	0,4				
	-0,6	-0,6	-0,5	-0,5	-0,6	-0,6	-0,6	-1,0	-0,6	-0,8	-0,8	-0,6				
Last cycle	M1	M2	M3	M4	M5	M6	M7	M8	M9	M10	M11	M12	M13	M14	M15	M16
	0,4	0,5	0,6	0,6	0,6	0,8	0,7	1,1	0,7	0,7	0,7	0,5				
	-0,6	-0,6	-0,4	-0,5	-0,7	-0,7	-0,6	-1,1	-0,7	-0,8	-0,9	-0,6				
Residual deformation	M1	M2	M3	M4	M5	M6	M7	M8	M9	M10	M11	M12	M13	M14	M15	M16
	-0,1	0,0	0,0	0,1	0,0	0,0	0,0	-0,1	0,0	0,0	0,0	0,0

All dimensions in mm

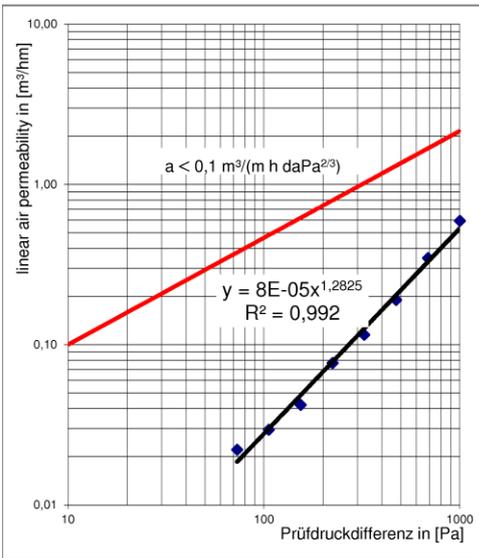
Graphics at positive wind pressure

Pressure difference in Pa	50	73	106	154	224	325	473	688	1000
Flow rate in m³/h	*)	*)	*)	*)	*)	*)	*)	*)	*)
Flow rate, in m³/hm	*)	*)	*)	*)	*)	*)	*)	*)	*)

\*) no measurable airflow

**Result:** Q10= 0,00 m³/hm  
 Q100= 0,00 m³/hm

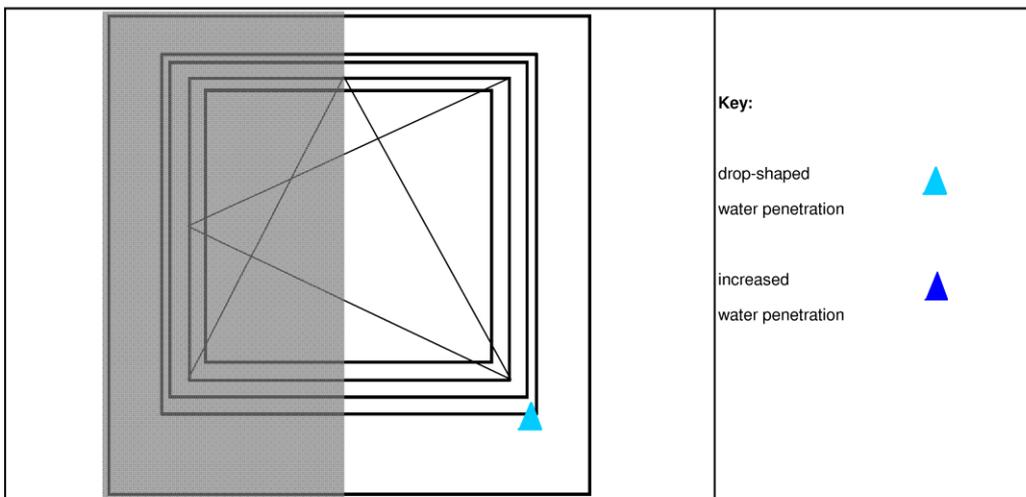
Amount of water: 480 l/h  
 0.48 m³/h

Three pressure pulses with 660 Pa were applied.

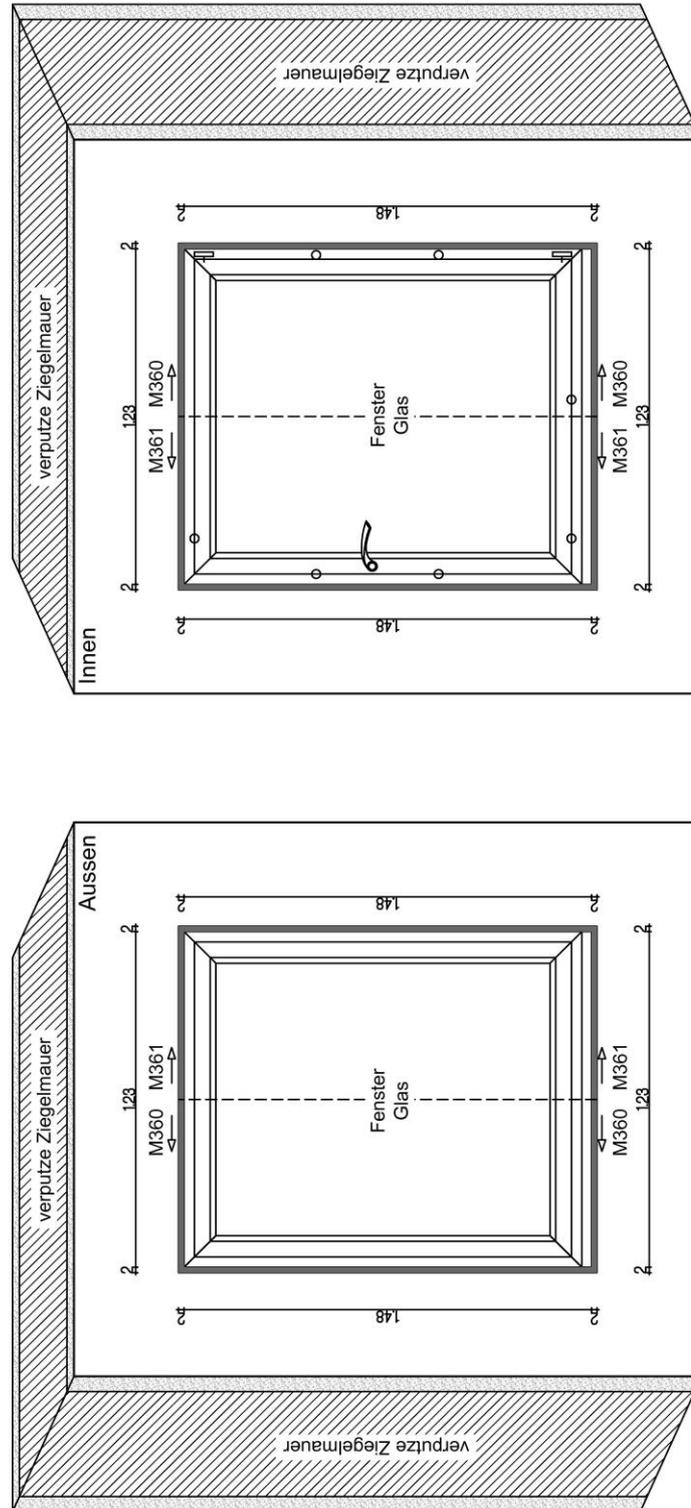
OTTOSEAL® M360  
 OTTOSEAL® M361

**Drawing 1**  
 Test specimen  
 Tested variant: OTTOSEAL M360

The test specimen consists of a bricked steel frame, which has a wall opening for window installation. A single sashed tilt and turn window is installed in the wall opening. The test specimen consisted of two sealing variants, whereby this test report covers the left half (seen from the inside). The external, lower connection was not subject of the test.

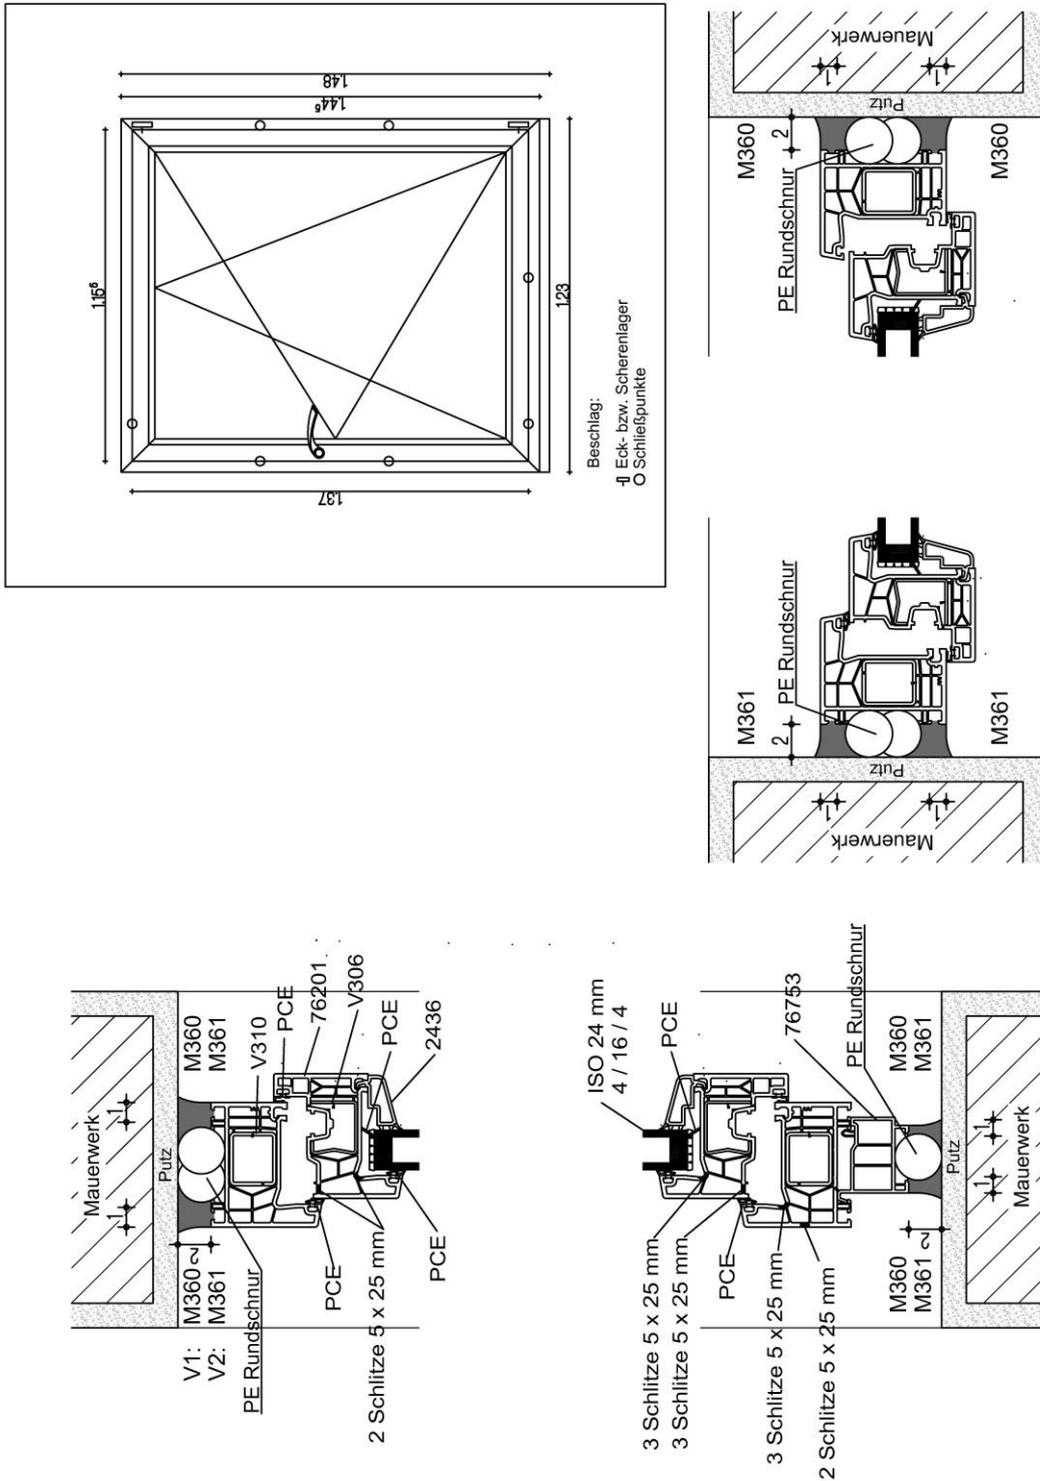
**Drawing 2**  
Sectional drawing of the test specimen  
Tested variant: OTTOSEAL M360

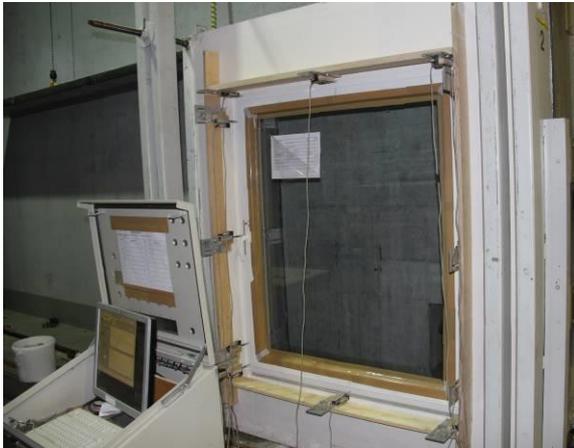
**Photo 1**  
Test specimen on test rig

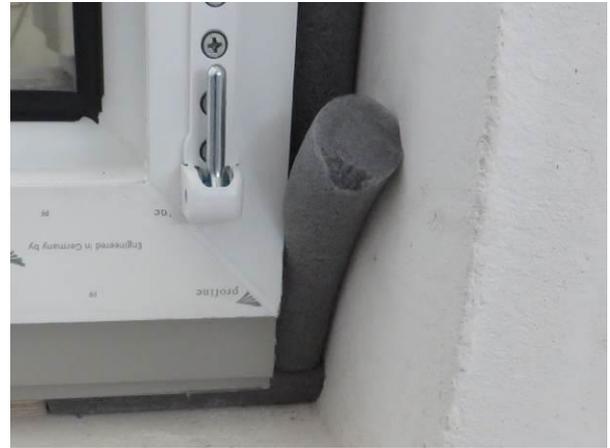
**Photo 2**  
Detail view, backfilling of sealant joints

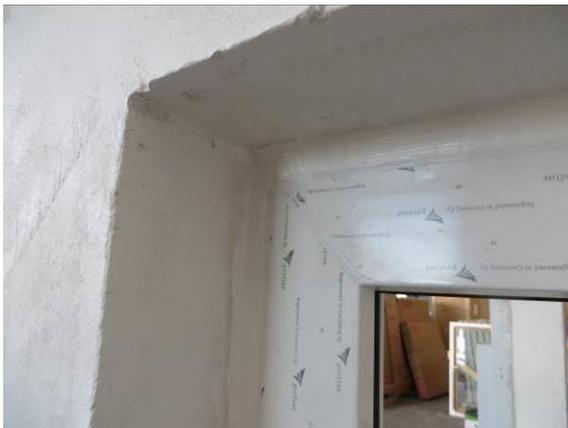
**Photo 3**  
Corner design of sealing, outside at top

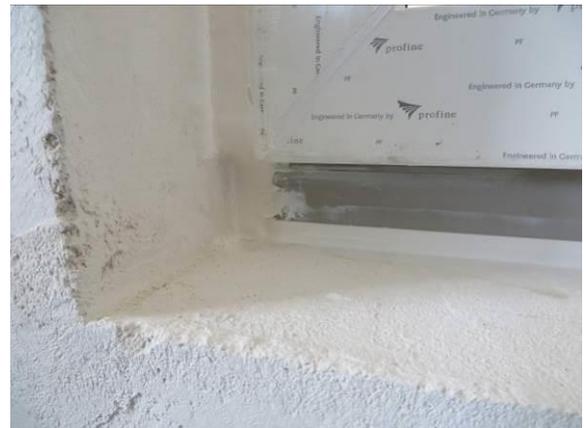
**Photo 4**  
Corner design of sealing, outside at bottom (not part of the test)

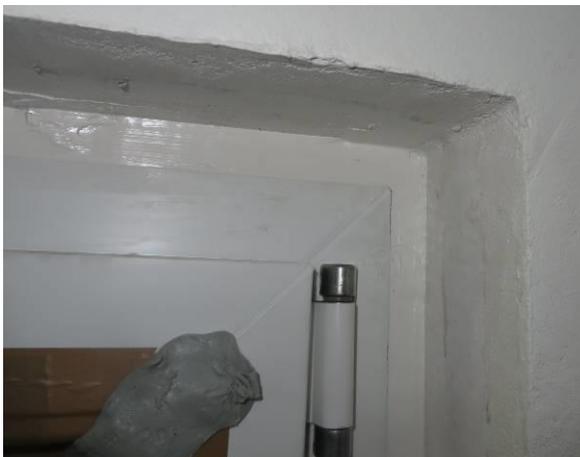
**Photo 5**  
Corner design of sealing, room side at top

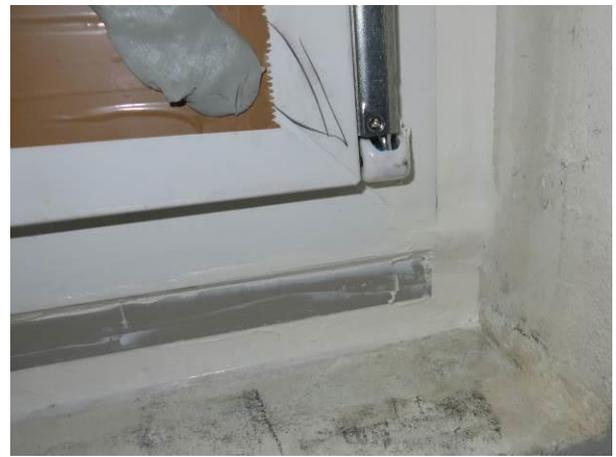
**Photo 6**  
Corner design of sealing, room side at bottom

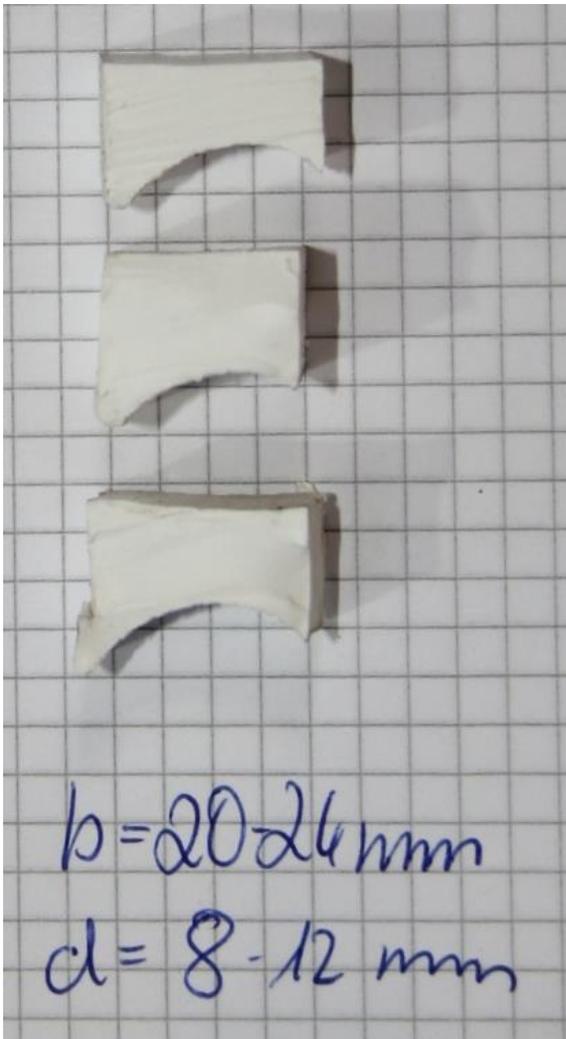
**Photo 7**  
Test pieces of seal on room side after dismantling of frame

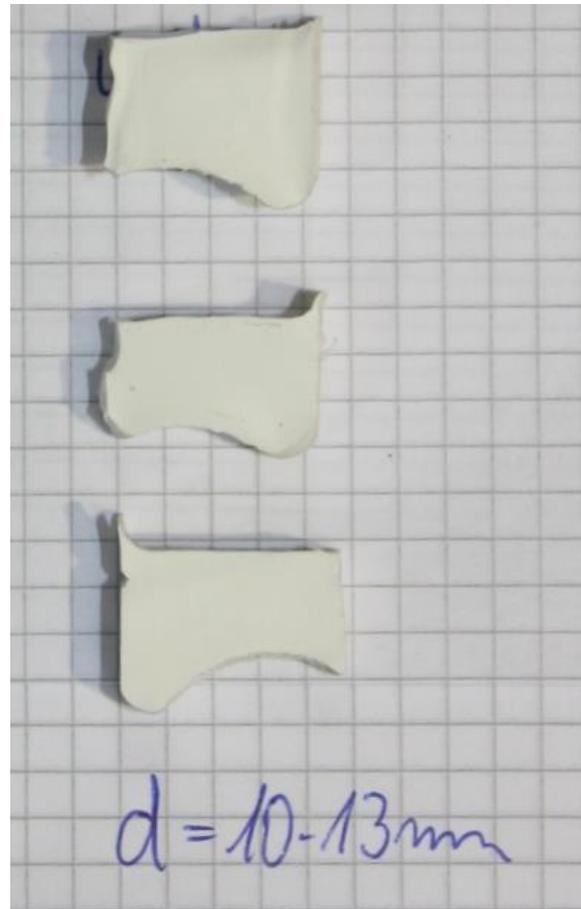
**Photo 8**  
Test pieces of external seal after dismantling of frame
